ON-SITE AIR BAG NON-DEPLOYMENT INVESTIGATION

CASE NUMBER - IN-06-033

LOCATION - WISCONSIN

VEHICLE - 2005 CHEVROLET COBALT

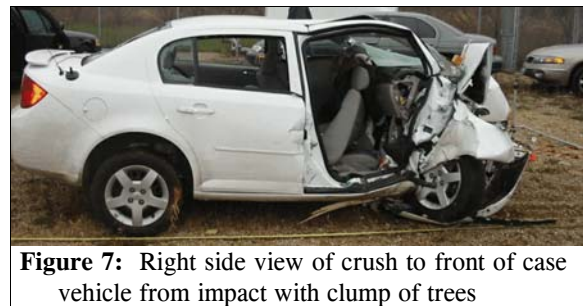
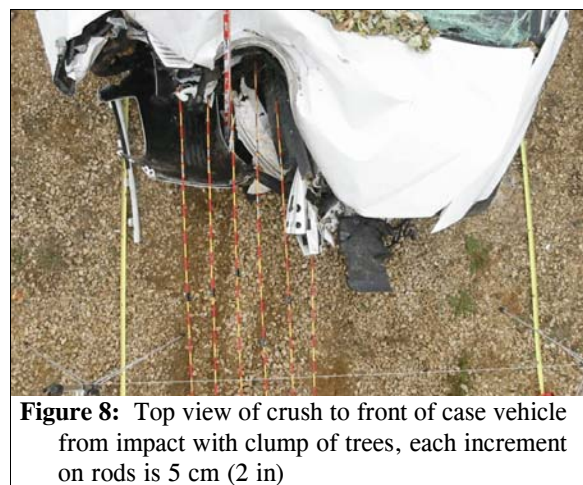
Exterior Damage: The case vehicle's initial impact with the telephone utility box involved the center portion of the front bumper. The precise location of the damage on the front bumper from the telephone utility box could not be determined due to the overlapping damage from the subsequent tree impact and missing portions of the front bumper fascia. The case vehicle's impact with the tree involved the front right portion of the case vehicle. The front bumper, grille, hood, and right fender were directly contacted and crushed rearward. The direct damage began at the front right bumper corner and extended approximately 45 centimeters (17.7 inches) along the front of the of the vehicle. The front crush profile was taken at the bumper level. The maximum residual crush was determined to be 121 centimeters (47.6 inches) occurring at C₃ (**Figures 7 and 8**). The direct damage from the tree branch impact involved the roof and the backlight. There was a dent located near the right "C"-pillar and the backlight was broken out. The table below shows the case vehicle's front crush profile.

The case vehicle's right side wheelbase was reduced 58 centimeters (22.8 inches). The left side wheelbase was extended 5 centimeters. Induced damage involved the left fender, hood, roof, right front door, right "A"-pillar and right roof side rail. The rescue crew cut the right "A"-pillar and removed the right front door.
